SUBJECT: DETERMINATION OF SIGNIFICANCE, MODIFICATION
TO HISTORIC STRUCTURE AT 1245 PARK STREET
(OLD BANK OF AMERICA BUILDING / ALI'S)

DATE: JANUARY 20, 2004

CLIENT Ali Salmanzadeh
 PROJECT 1245 Park Street, Paso Robles, CA
Seismic Structural Repair

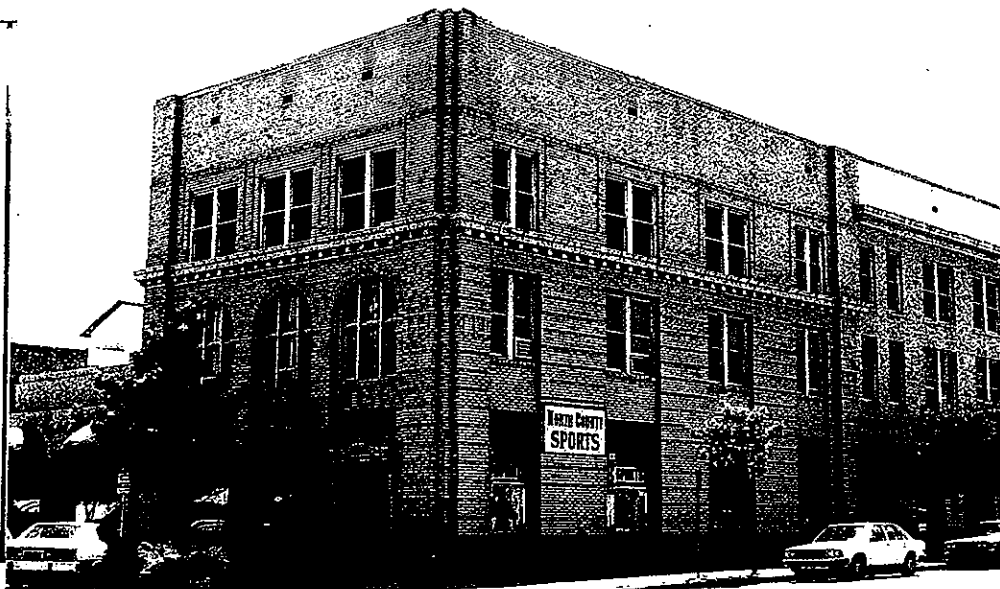
- 7a. Architectural style: Classic Revival
- 7b. Briefly describe the present *physical description* of the site or structure and describe any major alterations from its original condition: Old, brick-on-concrete; three-story, flat-roofed bank. Quoin-like brick corners, and recessed/columnar window openings. A plain brick band runs the perimeter of the building above the third-story windows. Third-story windows are double hungs with square openings. Second story topped by a horizontal decorated stone band that encircles the building. Front, second-story windows are latticed panes with semi-circular openings of radiating brick. Street level windows have latticed transoms, off-center door has stepped-stone pediment topped by latticed transom. Three glass panel wooden door. Building is not earthquake reinforced. Upstairs is vacant.

3. The "Old Bank of America Building" is included in the City's Historic Resources Inventory. Attached is the excerpt from the inventory regarding that structure. (Please note that the statement regarding the building not being earthquake reinforced is no longer accurate; since the survey was taken, the property owner made substantial improvements to retrofit the subject building.)

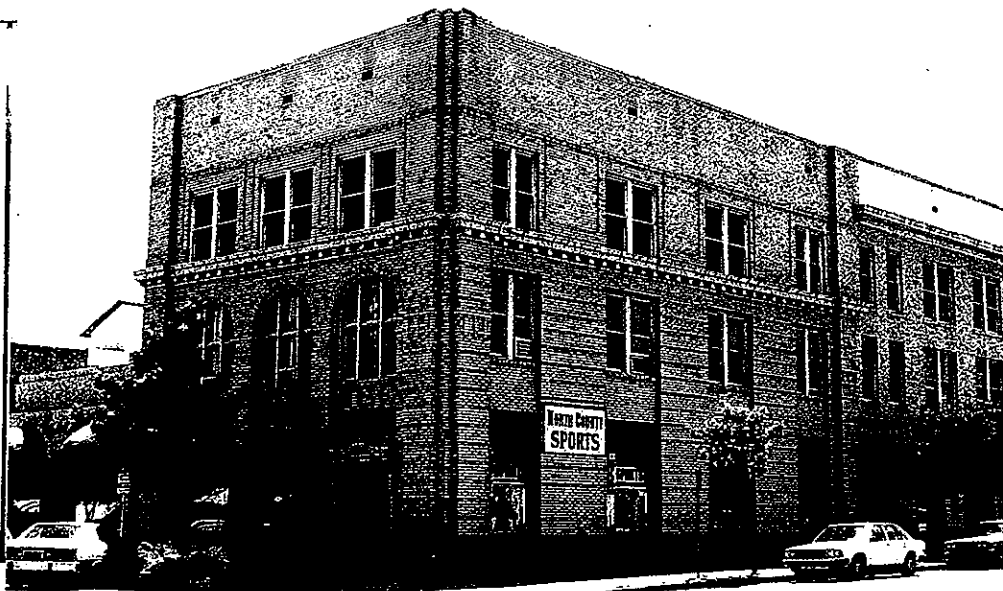
- 7a. Architectural style: Classic Revival
- 7b. Briefly describe the present *physical description* of the site or structure and describe any major alterations from its original condition: Old, brick-on-concrete; three-story, flat-roofed bank. Quoin-like brick corners, and recessed/columnar window openings. A plain brick band runs the perimeter of the building above the third-story windows. Third-story windows are double hungs with square openings. Second story topped by a horizontal decorated stone band that encircles the building. Front, second-story windows are latticed panes with semi-circular openings of radiating brick. Street level windows have latticed transoms, off-center door has stepped-stone pediment topped by latticed transom. Three glass panel wooden door. Building is not earthquake reinforced. Upstairs is vacant.
